24 February 2006

Re: _____
Our File No. 260011

In accordance with your request, a preliminary analysis was performed regarding the fall from elevation accident to _____ tore at _____ Palo Alto, California. I have reviewed photographs provided by your office and have performed an informal inspection of the property.

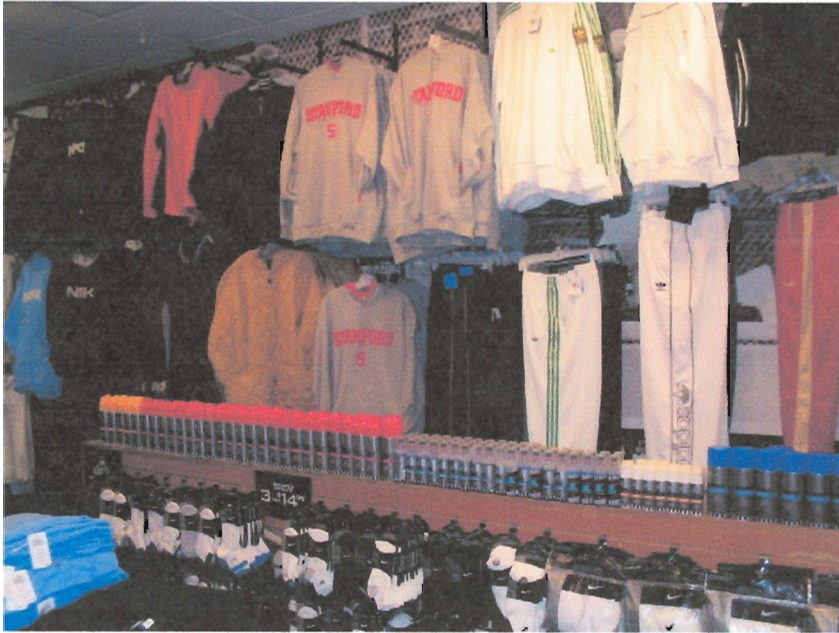
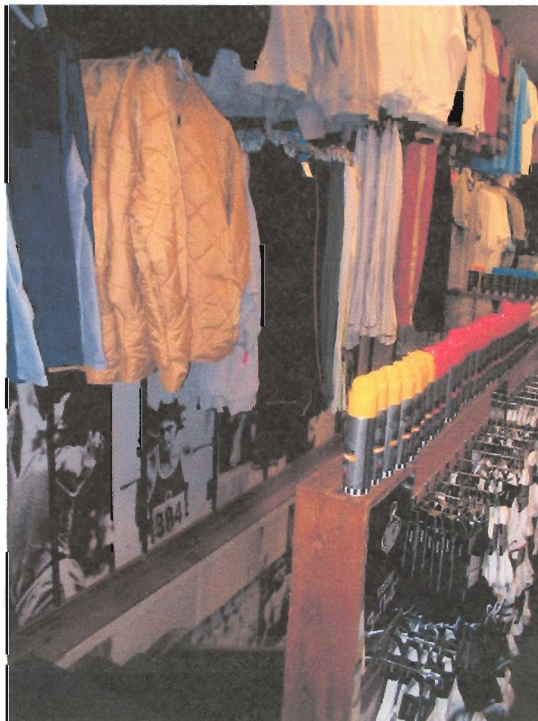
Based on examination of the photographs provided and my informal inspection, it is my opinion that the stairway is hidden from the patrons and creates a hazardous condition. The building wall has numerous clothing items across the length of the wall, which gives the impression that all of these items are accessible from the ground level. While in front of the shorter display wall, a person would see that the items to the left are accessible by just walking to the left of the shorter display wall. It would be reasonable to the patron to believe that to get to the items behind the shorter display wall, one would only have to walk around the shorter display wall. There are no visual cues prior to the actually negotiating around the shorter display wall that there is a stairway. The subject stairway starts behind the wall and there is no handrail beyond the top nosing of the stairway, as required by the Uniform Building Code, which would signify the start of a stairway.

There was a gate/barrier on the top of that stairway that hinges on the wall and connects to the shorter display wall that apparently was not closed at the time of the fall. In addition, the words "Keep Out" are on the side of the gate that would have been hidden from view when the gate is in an open position and against the wall.

The following photographs depict the hidden stairway behind the shorter display wall and the location of items along the building wall:
